APPENDIX 1

HISTORIC MAPS

APPENDIX 4

PHOTOS OF SITE

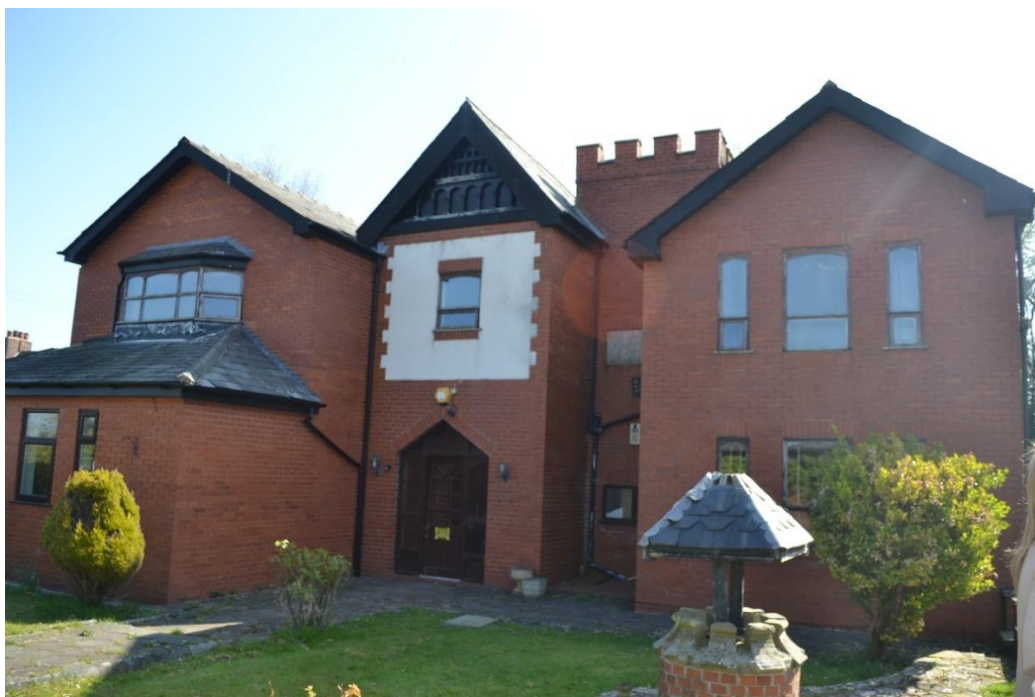
Figure 16: West elevation rendered with unique chimney stack- note the lack of fenestration in the final bay suggesting a potential later alteration not in keeping with the asymmetrical existing fenestration across the building.

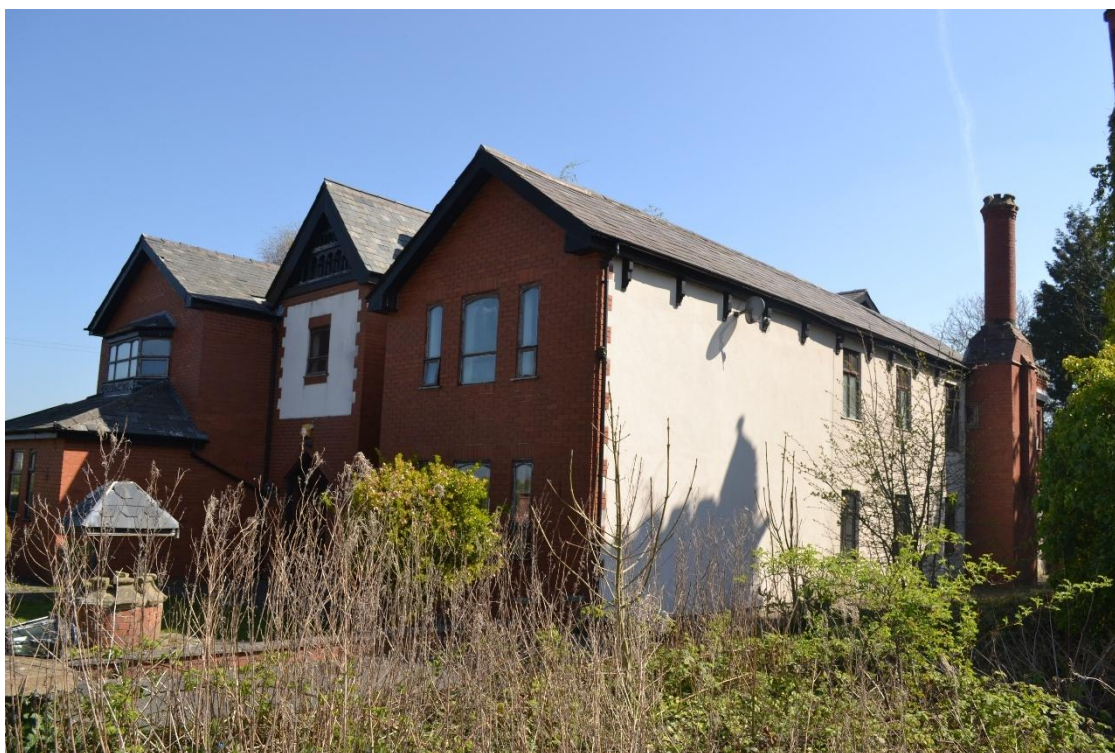
Figure 17: Note the masonry changes along the west wing suggesting later alteration and extensions

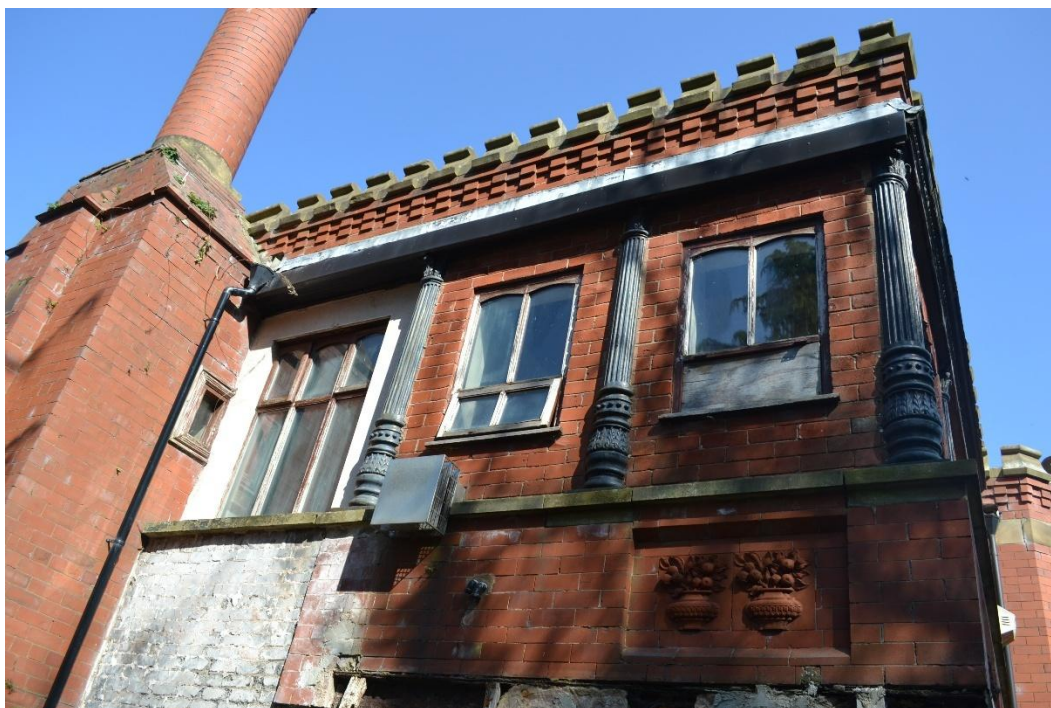
Figure 18: Detail of western corner of South (front elevation). Again note the inappropriate fenestration. Also note the single storey projecting extension and evidence across the brick work of the first floor (outlined in yellow) suggesting a later first storey extension to the wing and the principal building to match the design of the principal building

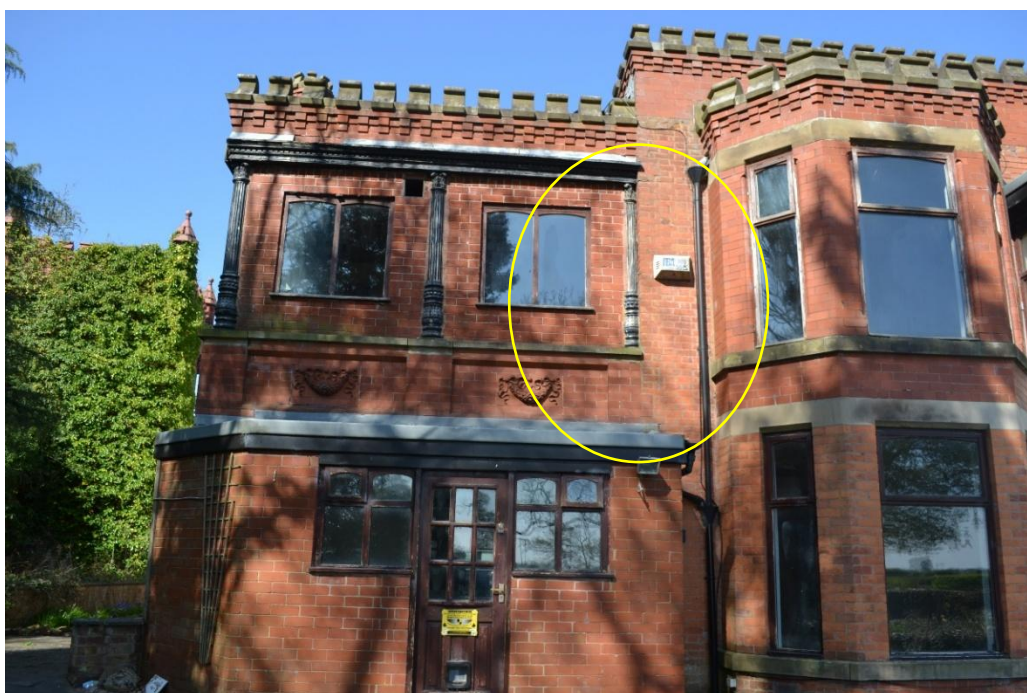
Figure 19: South (front elevation). Note the inappropriate infill porch which appears in the late 20th century and has disrupted the original plan form of the principal rooms on the first floor.

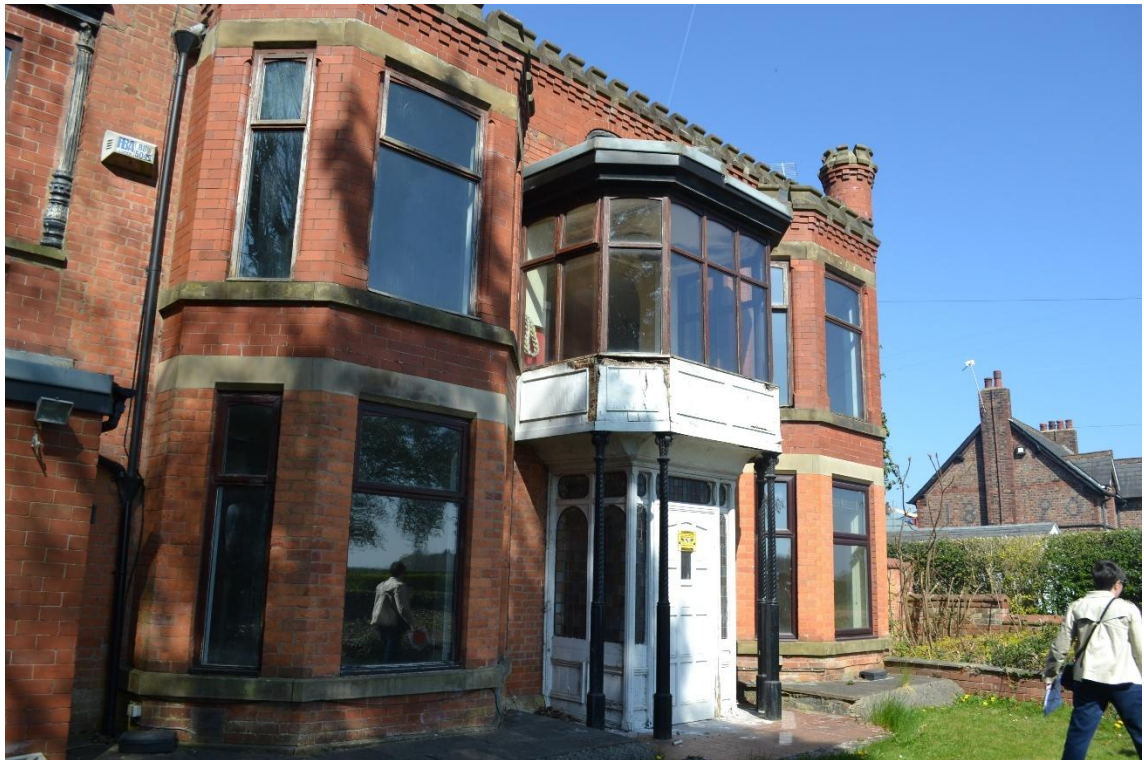
Figure 20: Central porch to southern elevation- a later infill addition in the 20th century

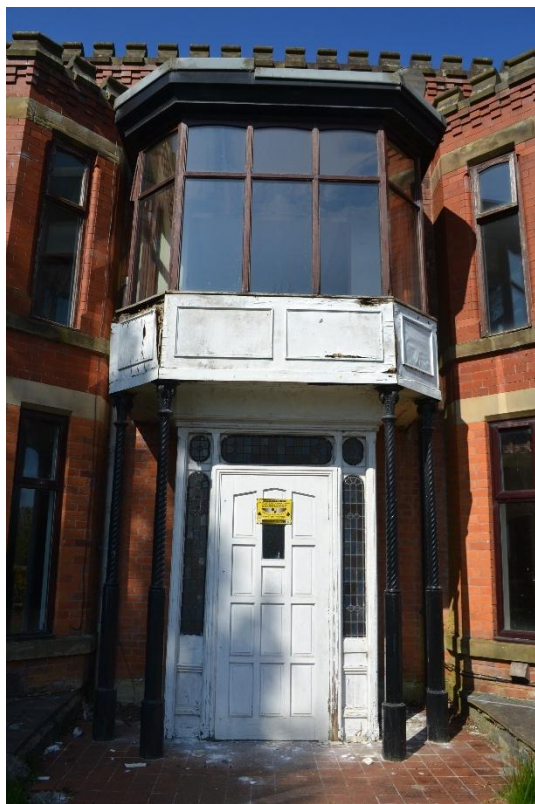
Figure 21: Southeast corner of front elevation. Note the patina of the brickwork on the ground floor bay window suggesting later repair.

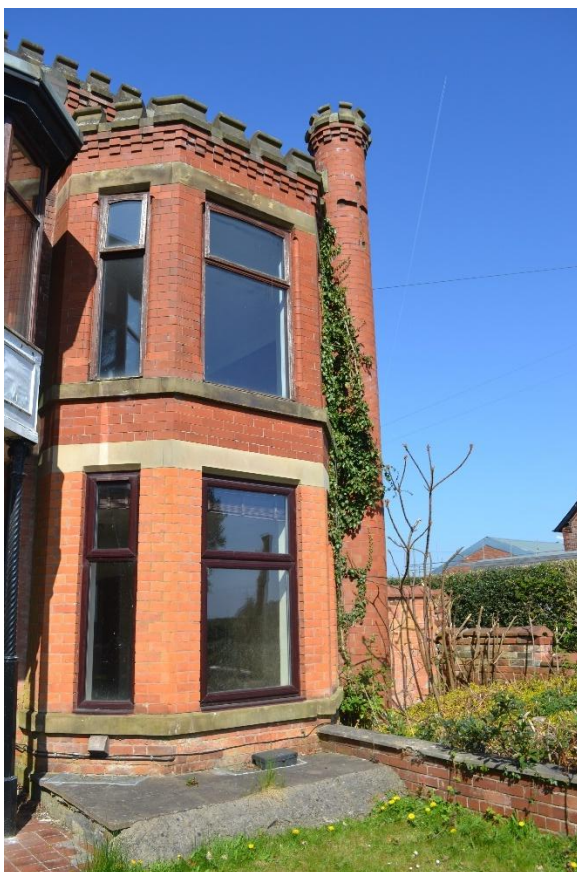
Figure 22: Southern front elevation where the unique architecture of the building can be appreciated. However there have been alterations such as extensions to the west wing and the inappropriate porch infill.

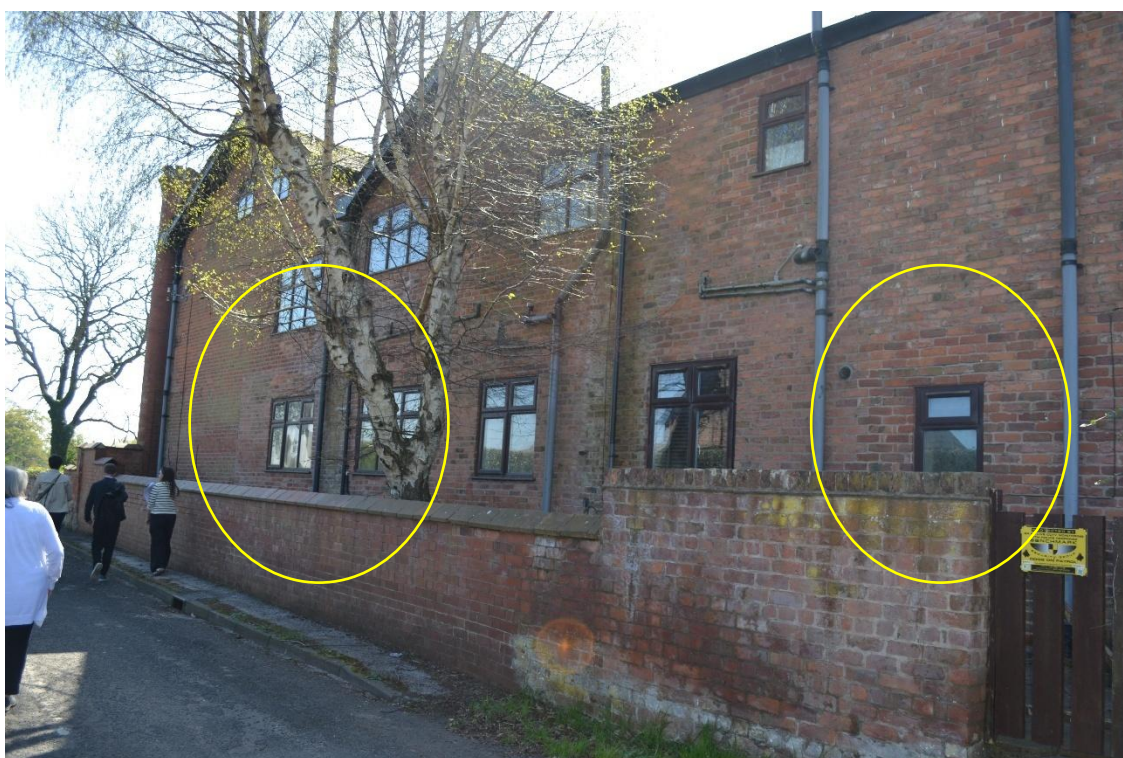
Figure 25: East elevation- note the brickwork highlighted in yellow where the courses do not tie in together suggesting each of the bays were constructed at later dates and not contemporaneously with the principal core

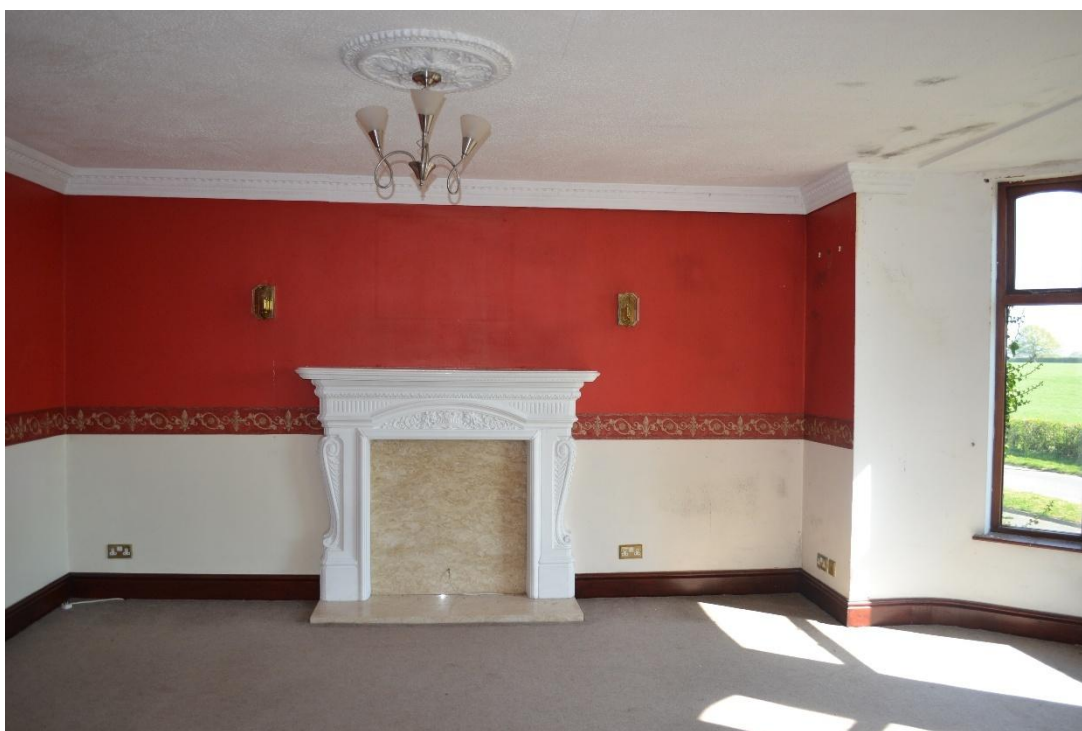
Figure 34: Disruption of first floor principal southern rooms due to porch infill and first storey creating an opening within the original elevation and between the rooms. One of the examples of the disrupted plan form internally.
