APPENDIX 1

HISTORIC MAPS

APPENDIX 4

PHOTOS OF SITE

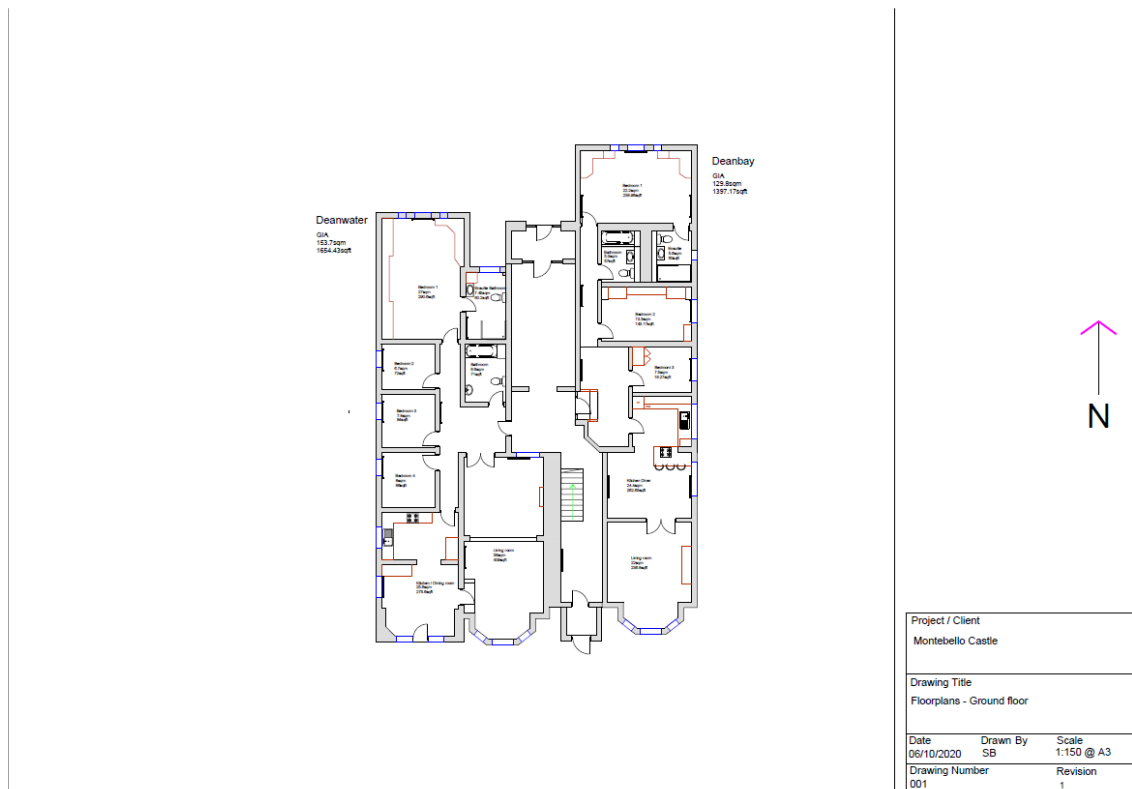
Figure 9: Existing ground floor plan illustrating the subdivision of the wings alongside the principal core of the Castle. Likely extensions and alterations to the east and west wings (evidenced in the masonry images below) as well later subdivision. Further note the central porch extension which has slightly disrupted the original symmetry of the front elevation and the infilling of the once open central core running north-south connecting the wings.

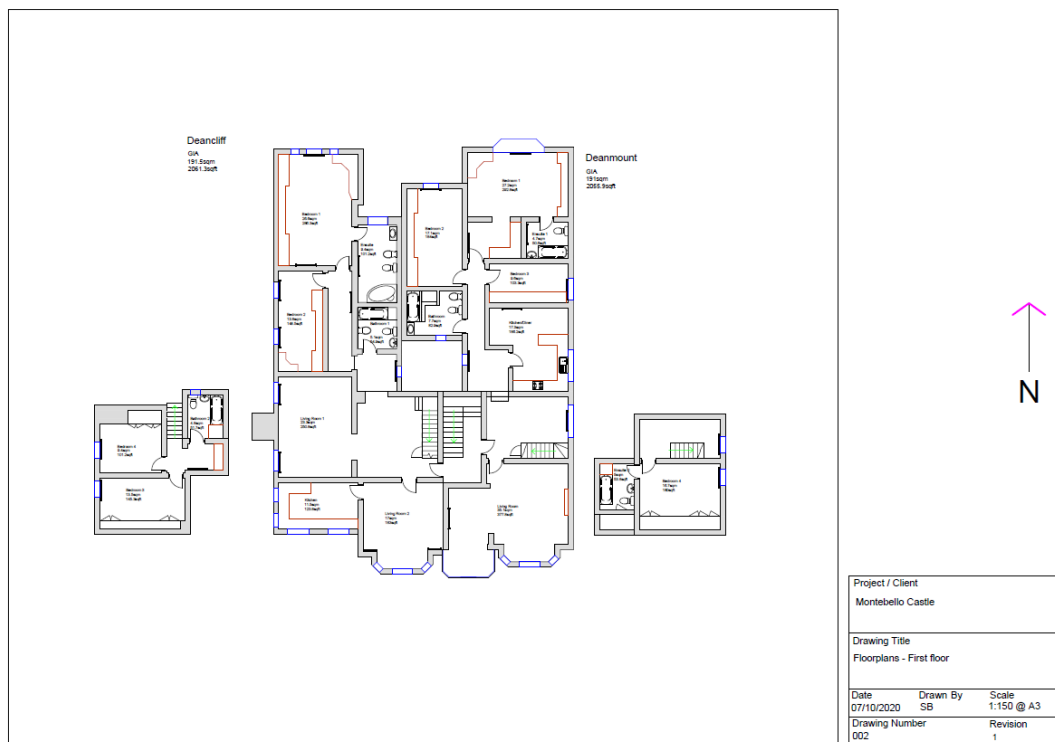
Figure 10: Existing First Floor Plan. Same as above. Note the disruption of the two southern principal rooms to accommodate the insertion of the porch further illustrating the dilution of the historic plan form.

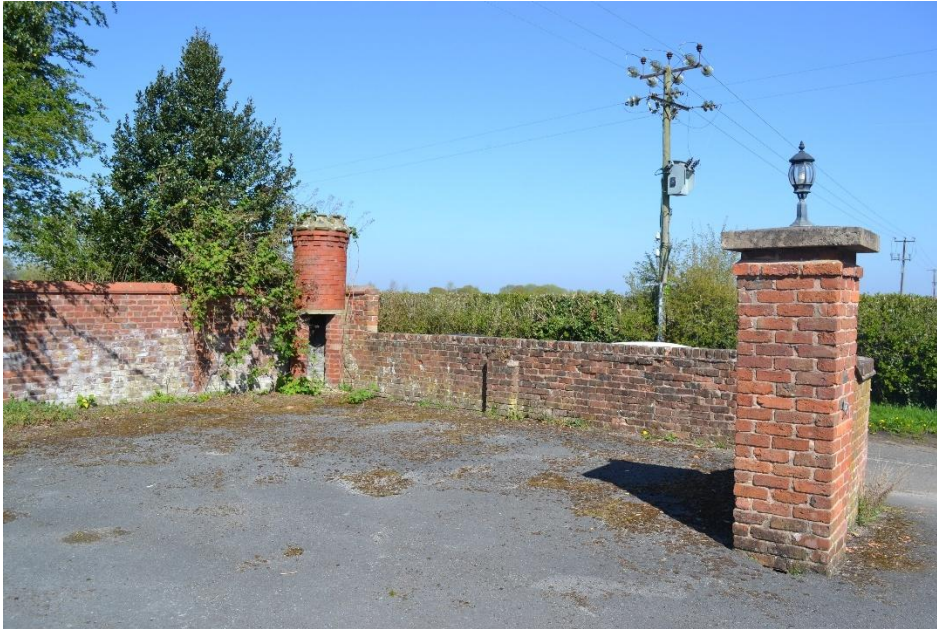
Figure 11: Brick boundary and detailing to north entrance to site.

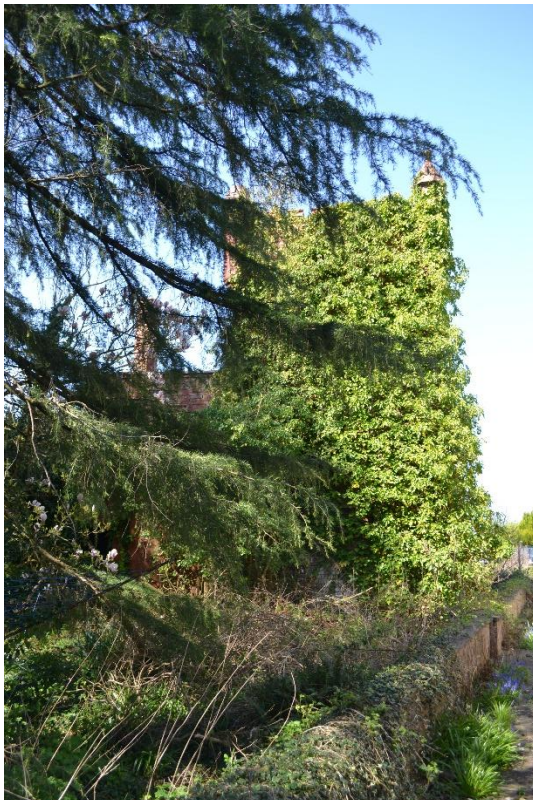
Figure 12: Water Tower east of the principal Castle building.

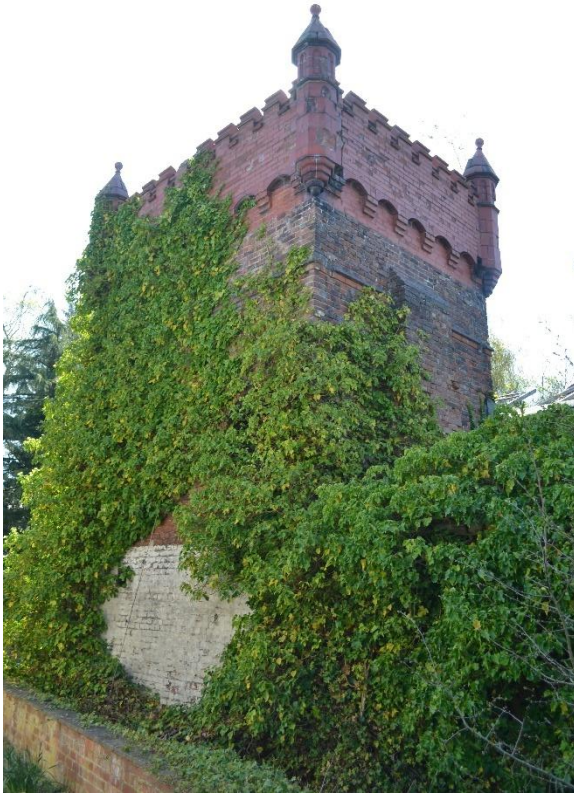
Figure 13: Water Tower to the east of the principal building.

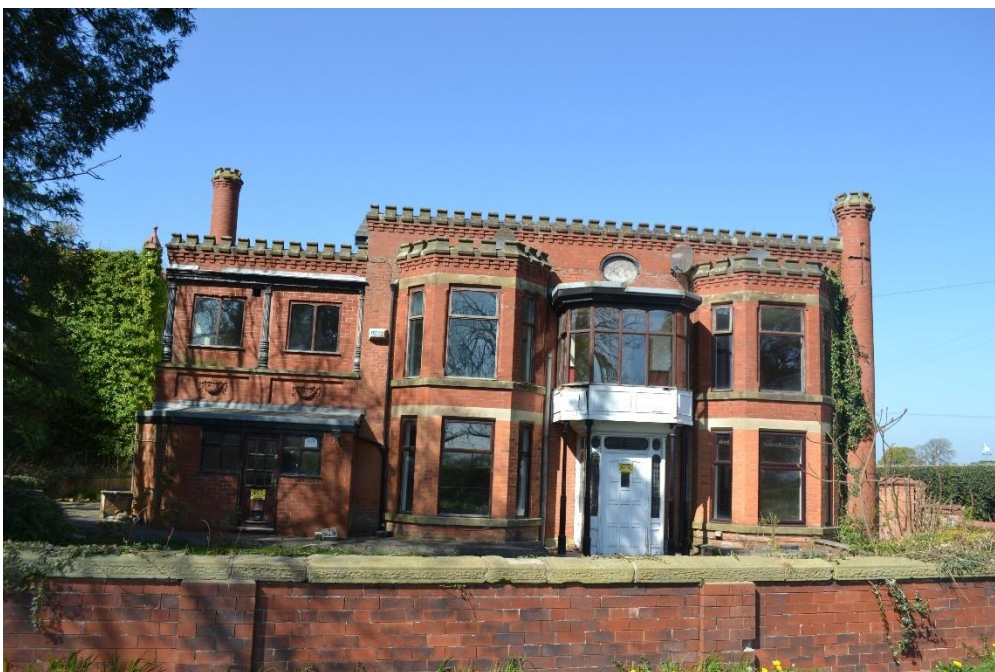
Figure 22: Southern front elevation where the unique architecture of the building can be appreciated. However there have been alterations such as extensions to the west wing and the inappropriate porch infill.

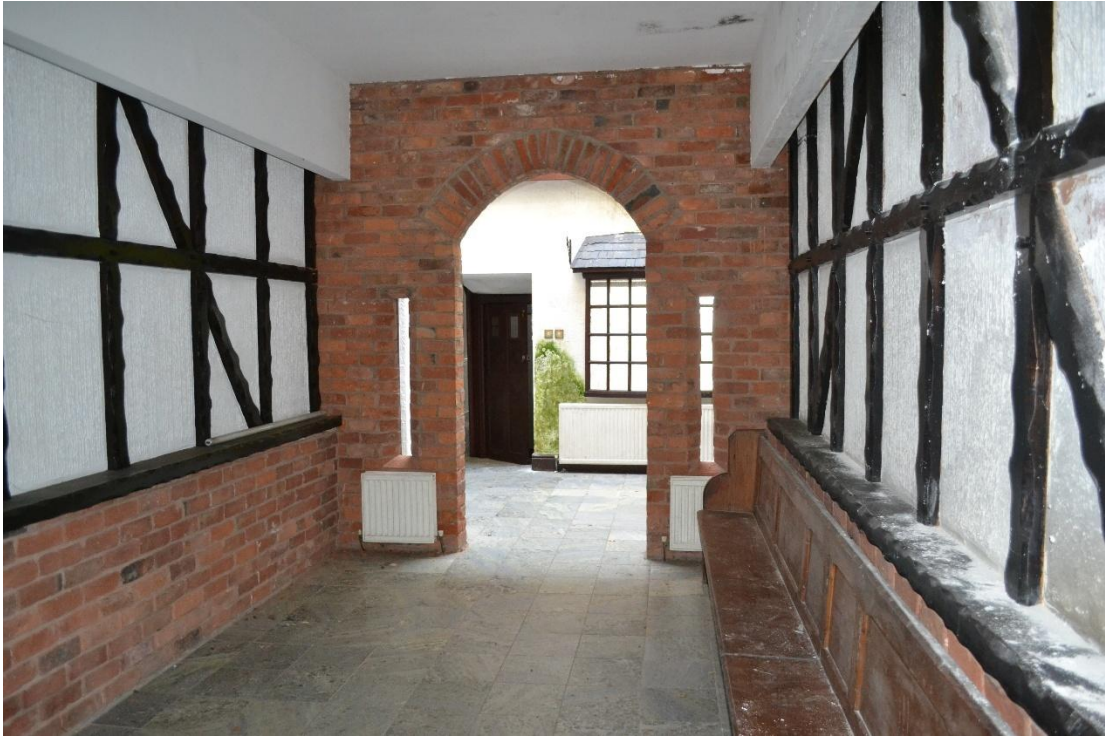
Figure 26: Central ground floor foyer which was once completely open, then glazed in the late 19th century, finally being infilled to accommodate the change of use in the later 20th century.

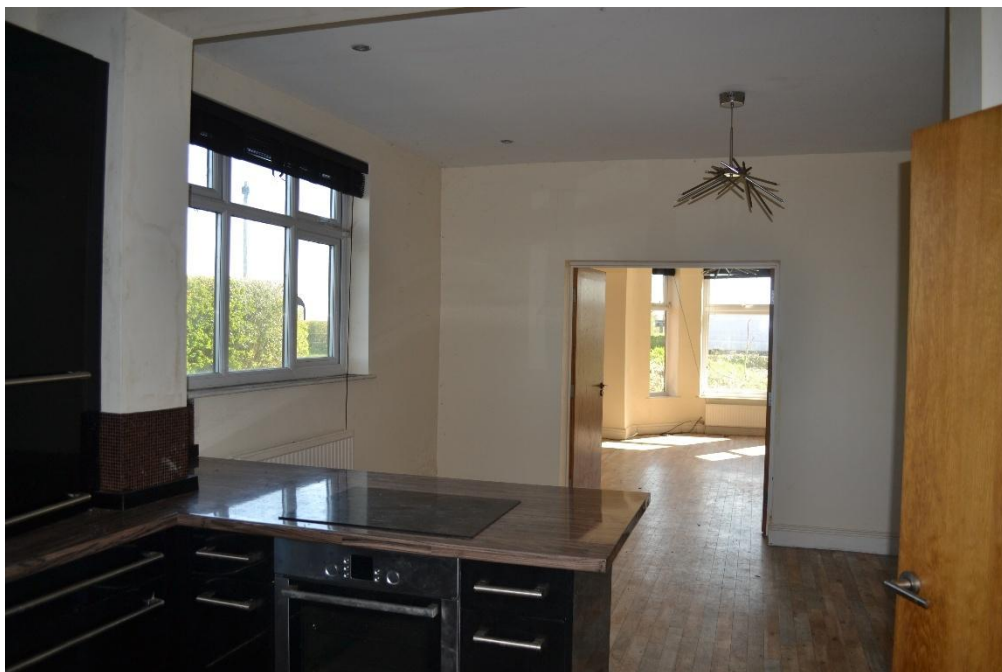
Figure 29: Example of typical kitchen layout in one of the ground floor units with stud walls for further subdivision. Note the lack of traditional materials, door, architectural detailing.

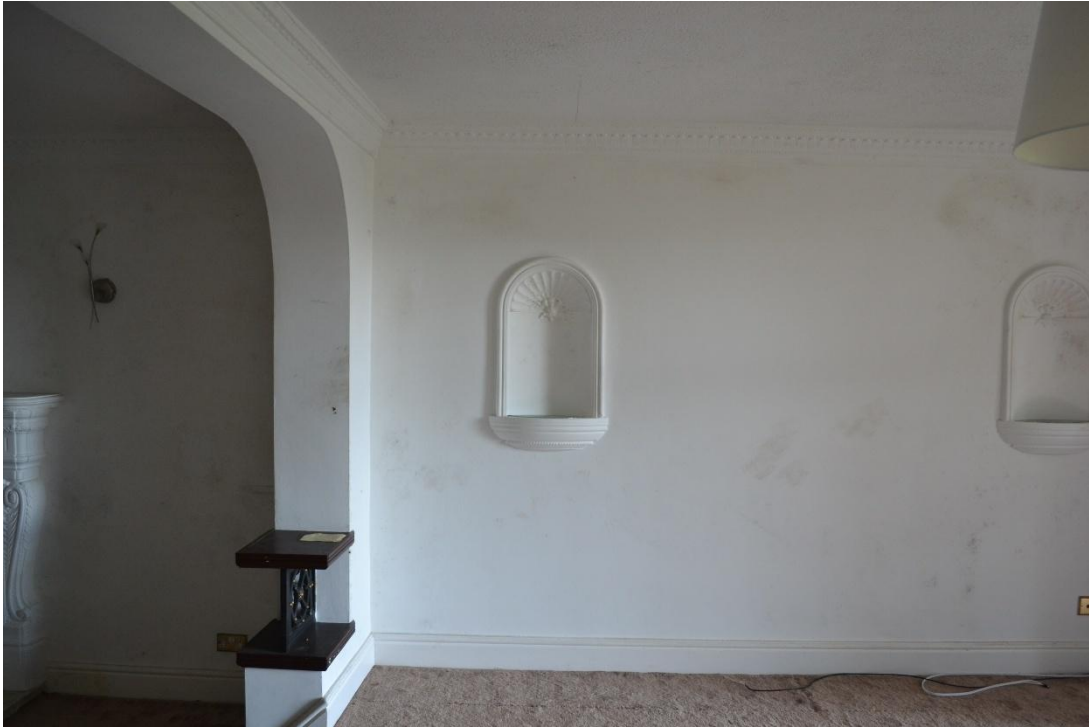
Figure 30: Example 'greek' detail on the ground floor. One of the sporadic stylings within the building which illustrate its use as a Greek Consul

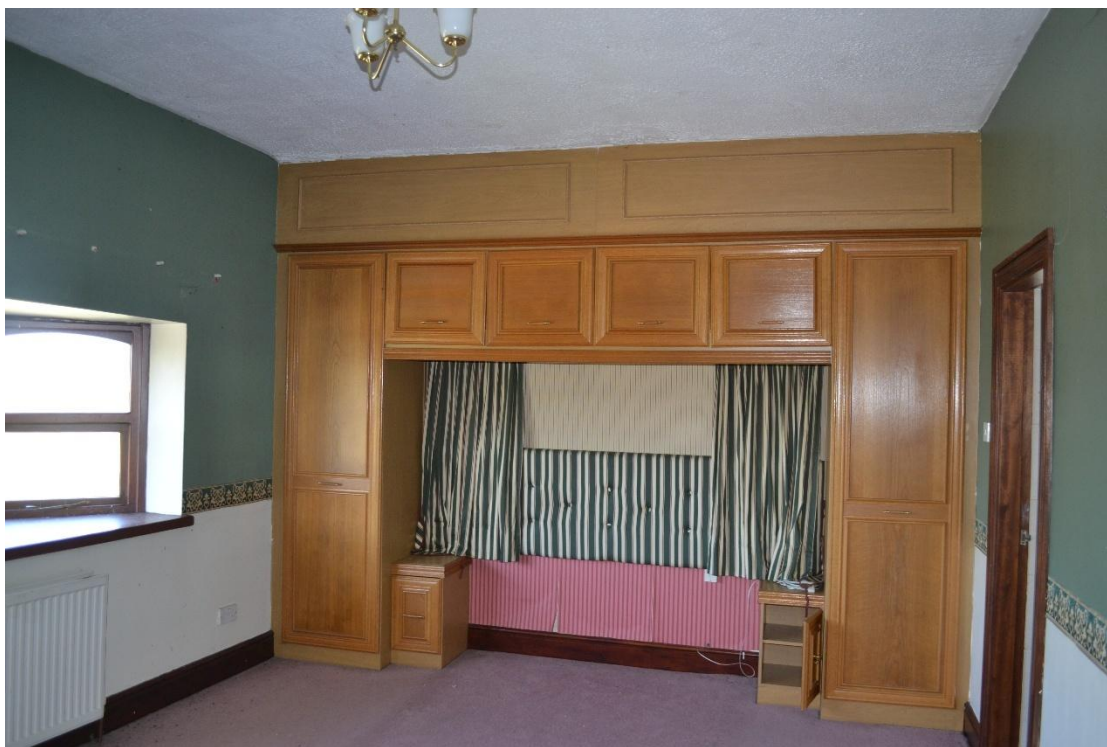
Figure 32: Typical fitted bedroom on the first floor. Note the lack of architectural detailing (cornicing, original doors etc)

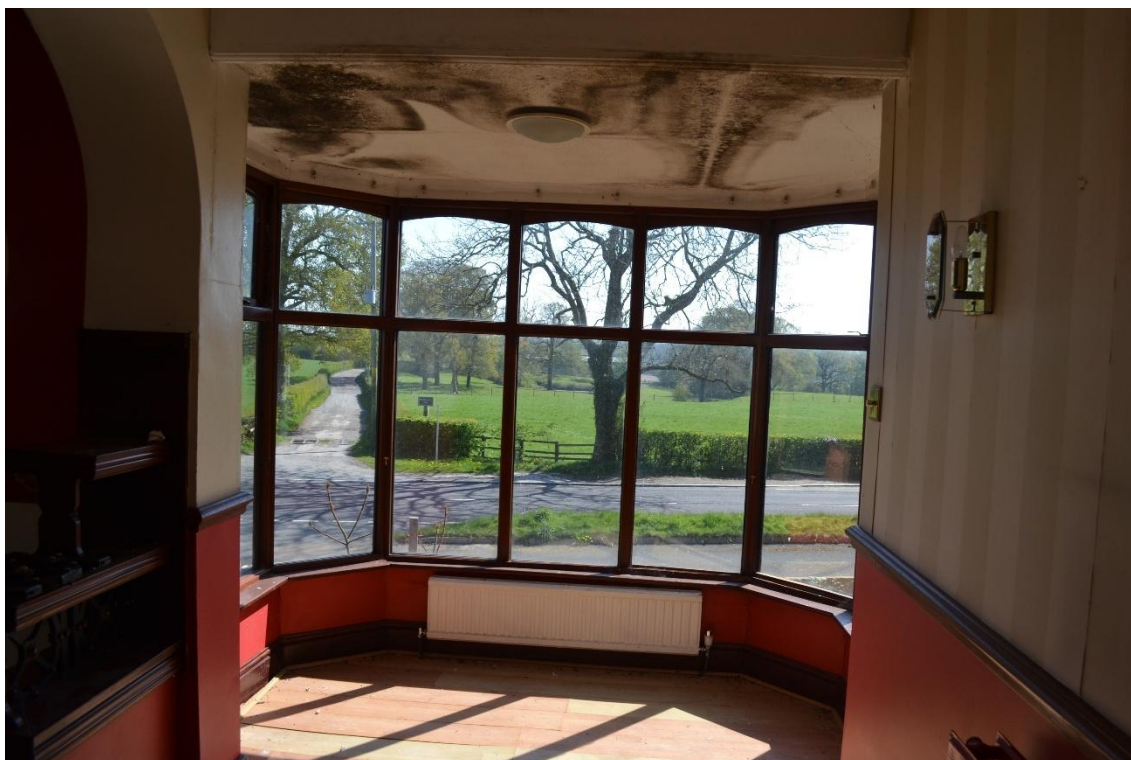
Figure 34: Disruption of first floor principal southern rooms due to porch infill and first storey creating an opening within the original elevation and between the rooms. One of the examples of the disrupted plan form internally.

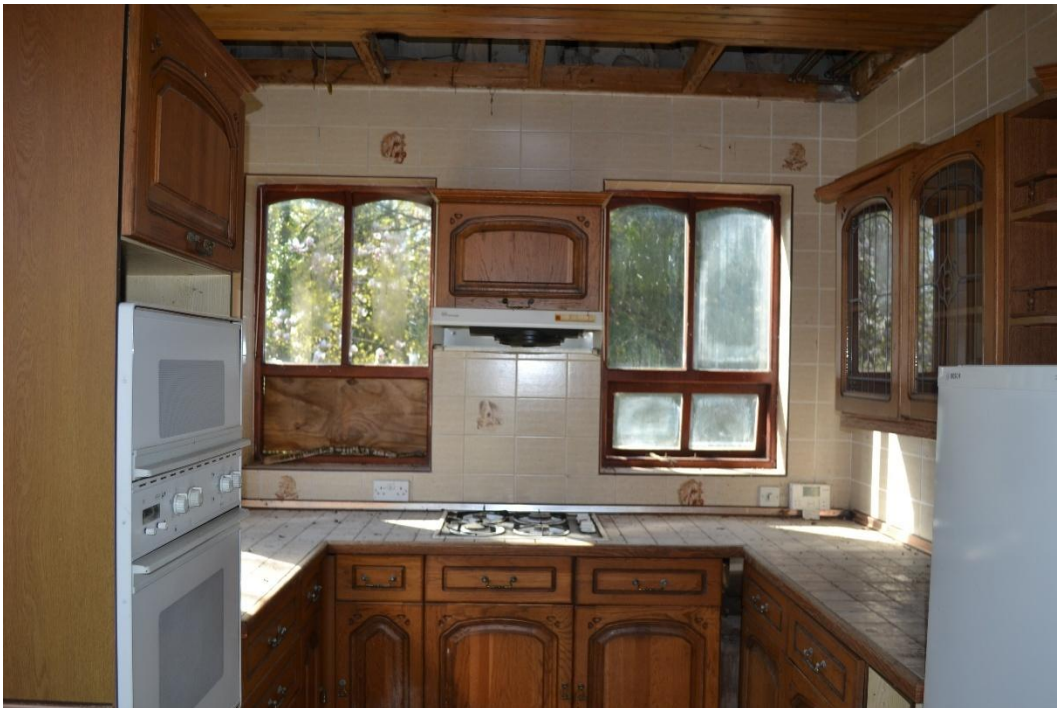
Figure 37: Typical kitchen suite on the first floor created by stud walls further indicating alterations to the original internal plan form.
